2022 Final Reserve Study Report

Crosswinds

For the period

From: January 1, 2022

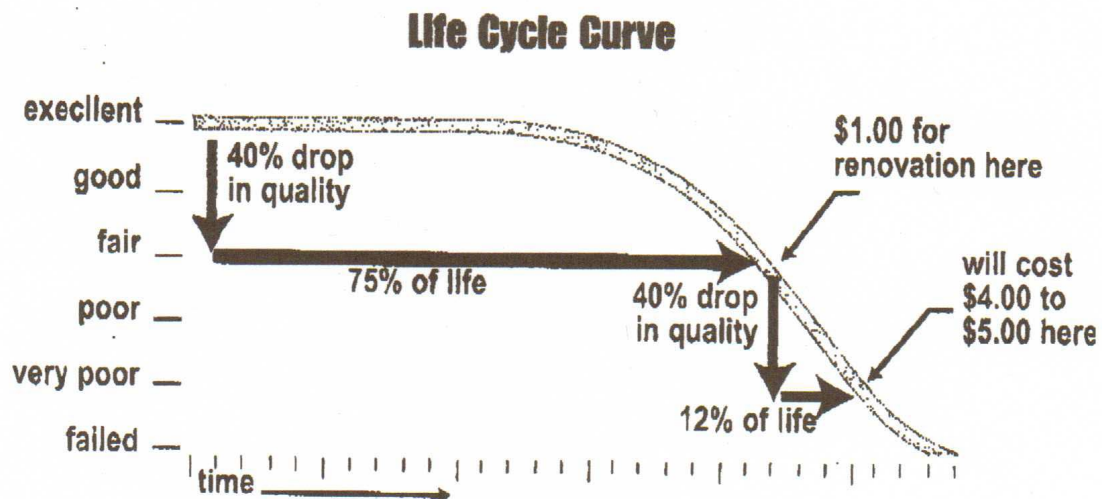
The life cycle graph (below) depicts the condition of a building system relative to its age. The curve can represent the deterioration of a number of building's systems, such as roofs, exterior walls, pavements, parking garages and decks. A basic understanding of the construction of these systems allows us to make a reasonable prediction of their performance and failure.

In the graph, the slope of the system condition curve is a function of the rate of deterioration of the system over time. Very few building exterior systems have a constant, or straight line deterioration curve. Normally, the rate of deterioration increases with time,

causing much more rapid deterioration in later years. As the rate of deterioration increases, so does the cost to repair. Maintenance performed at the right time can extend the need to expend a significantly greater cost for maintenance, pushing the performance curve to the right. An effective facility management system can program repairs at the right time to reduce the overall life cycle cost of maintaining the system.
